Manhole Inspection Summary

Manhole # S17UU1009MH

Insp Date: **5/23/07 10:19 AM**

Location Address: **CYLBURN AVE**

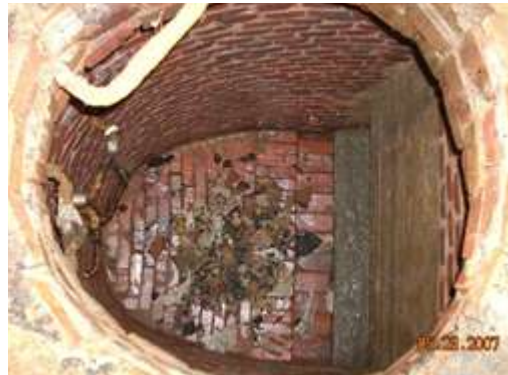
Top View

Bench ☒ Exists Material: **Brick** ☐ Parged ☒ **Debris** (not Condition related)

Steps Count: **5** Missing: **0** ☒ **Corroded**

Surcharge ☒ **Evidence Of Surcharge** Depth: **4** (ft.) ☐ Active Surcharge Present

Corroded steps. Evidence of surcharge - Bench debris.

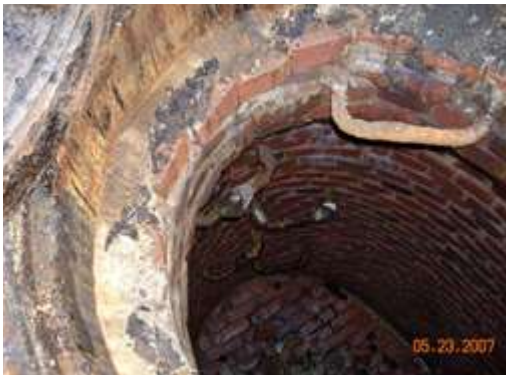
Defect

Frame Offset: **2** (in.) Condition: ☐ Sound ☐ Cracked ☒ **Leaks**

Condition: ☐ Sound ☐ Cracked ☐ Root Intrusion ☐ Loose Brick ☒ **Deteriorated**

Infiltration: ☐ None ☒ **Joint** ☐ Cracks ☐ Mortar ☐ Roots ☒ **Wall**

Frame leaks. Frame offset. Adjustment deterioration and infiltration.

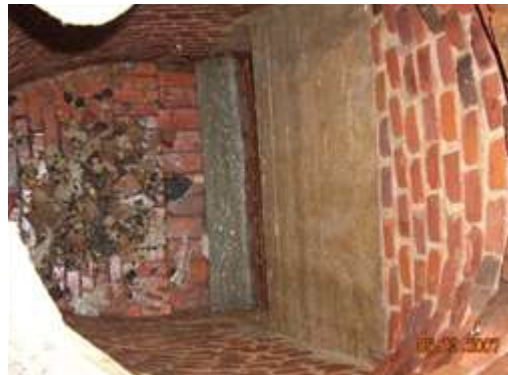
Defect

Infiltration: ☐ None ☐ Joint ☐ Cracks ☒ **Mortar** ☐ Roots ☒ **Wall**

Infiltration: ☐ None ☒ **Joint** ☐ Cracks ☐ Mortar ☐ Roots ☐ Wall

Corbel and Barrel infiltration.
